**Crew Change Point, West Hemlock, Oregon
Portland Subdivision, Kenton Line, Milepost 16.5**

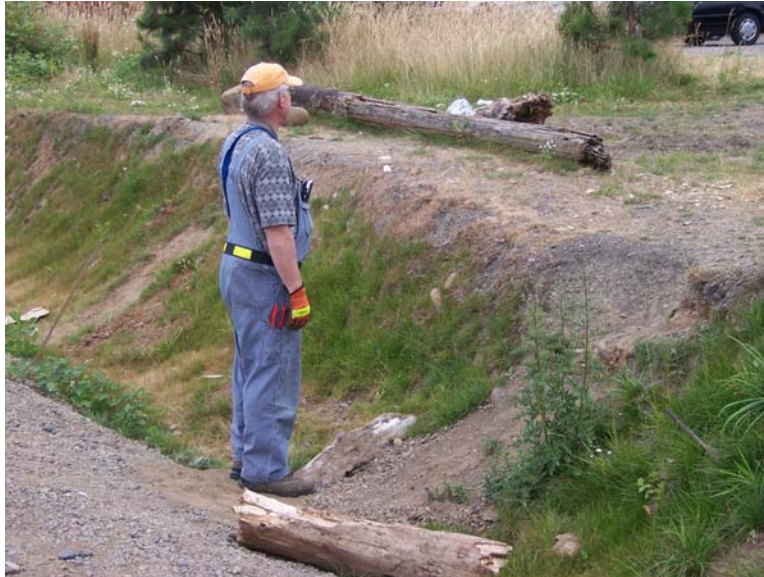
This gives a perspective as to the drop from the parking lot to the drainage ditch.

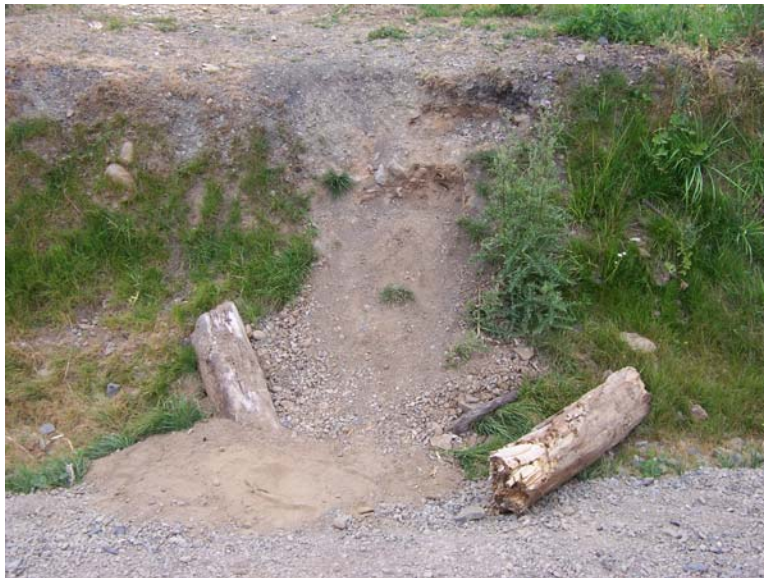
This gives some idea of the material the “footpath” that must be traversed to descend from the crew van drop-off area. Imagine what this will look like in January when it is pouring down rain. Also, the debris presents a tripping hazard. Serious consideration should be given to construction of stairs descending from the crew van drop-off area and a “bridge” across this drainage ditch.

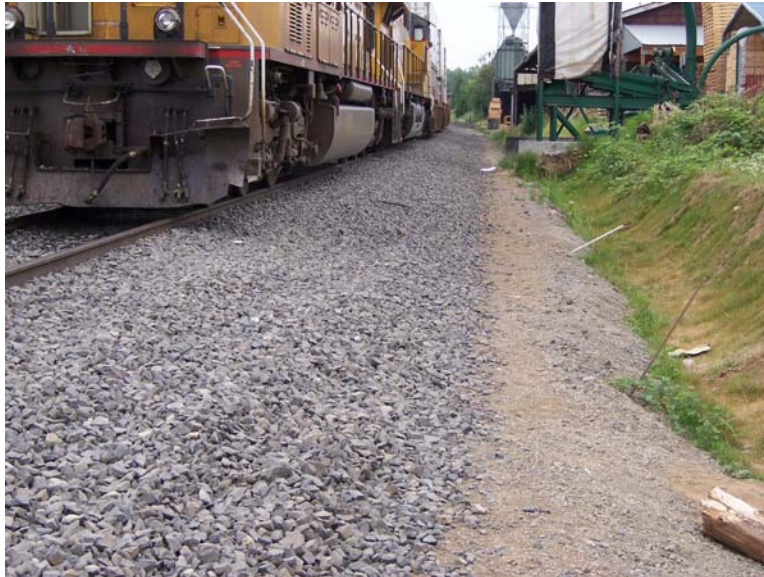
It appears that tamping work has yet to be completed in this view. The ballast is fairly large mainline-sized rock. Consideration should be given to mixing in smaller chips to stabilize the larger rock and provide better walking conditions.
